THE SPIGOT

Rural Water Assists North Dakota Utility After Tank Freezes

Rural Water Sewer Cam Helps Locate Blockage

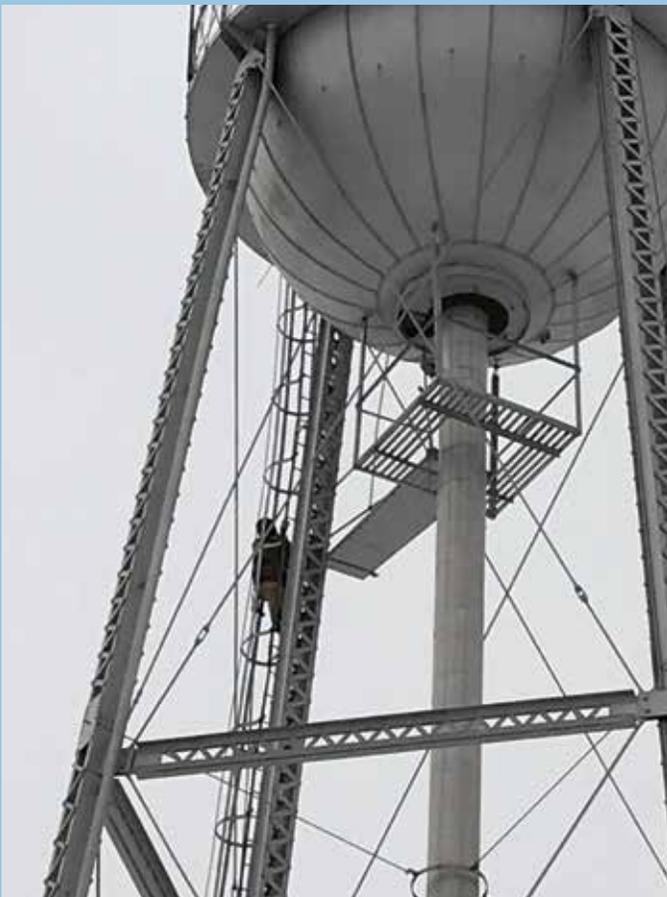
When ice blocked the intake of the Hannaford water tower, the pumps cycled erratically, pressure spiked in the distribution system, and malfunctions threatened to leave the community without water. Assistance from the North Dakota Rural Water Systems Association (NDRWSA) helped avoid disaster and restore water service.

“We had some insulation in the tank that slid down,” explained Hannaford City Auditor Ed Everson. “When we had several days of cold temperatures and high wind, the tank started to freeze.”

The ice over the tank intake confused the system and interrupted the normal filling process. “The water tower sensors were calling for water, but since the intake was blocked, the demand pumps were pushing straight into the distribution system,” Sheeley explained.

The contractor climbing into Hannaford tank to steam the frozen intake.

The following day, Hannaford Water Works Superintendent Roger Rondestvedt was cycling the pumps manually to maintain appropriate levels of pressure in the system. The contractor climbed into the tower and started cutting through the ice with steam. Once the contractor cut a sizable hole in the ice, Sheeley opened a fire hydrant on the edge of town to get more water moving through the system.

Moving water through the system helped cut through more ice. By about 4 p.m., the standpipe was thawed, and the tower was back in service. Sheeley advised Hannaford

to move water through the tower the next day and to set the water level as low as they were comfortable with to keep the water cycling.

Hannaford has been running without any further issues and has plans to repair the tank insulation in the summer.

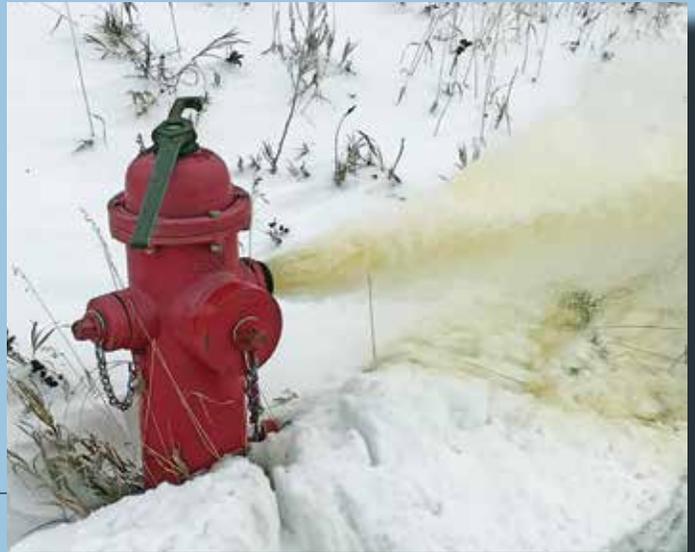
Flushing a Hannaford fire hydrant to get warmer water into the system.

“The water from the well is warmer,” Sheeley explained. “Plus, moving water won’t freeze.”

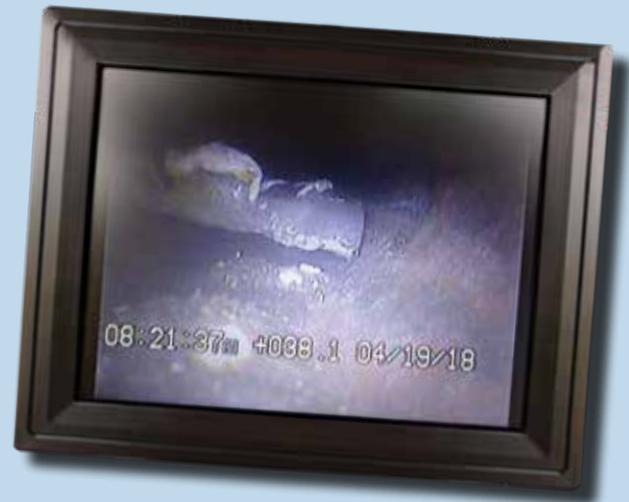
The sewer camera uses cables and a rolling mount that moves through pipes, transmitting and recording video of any possible obstructions. He started moving the camera through the sewer main at the nearest manhole.

“About 10 feet down, we found some misaligned tile,” Sigette said. “It wasn’t severe enough to cause the blockage, though.”

“The residential sewer line was shoved in completely through the main to the other side,” he said. “I’ve seen pipes shift before, but I’ve never seen it go all the through the city sewer main.”

It’s uncertain what caused the pipe to shift, but Sigette suspects it moved when the ground thawed and shifted. The line will have to be dug up and reinstalled with a saddle to prevent separation. Sigette’s assistance helped the community quickly locate the source of the problem and begin working on solutions, something that would not have been possible without NDRWSA assistance.
